SNOW AND ICE CONTROL IN CALIFORNIA

Carl Forbes, Carl Stewart & Don Spellman

To Be Presented at The Highway Research Board
Symposium on Snow Removal and Ice Control Research

Reference: "Snow and Ice Control in California"

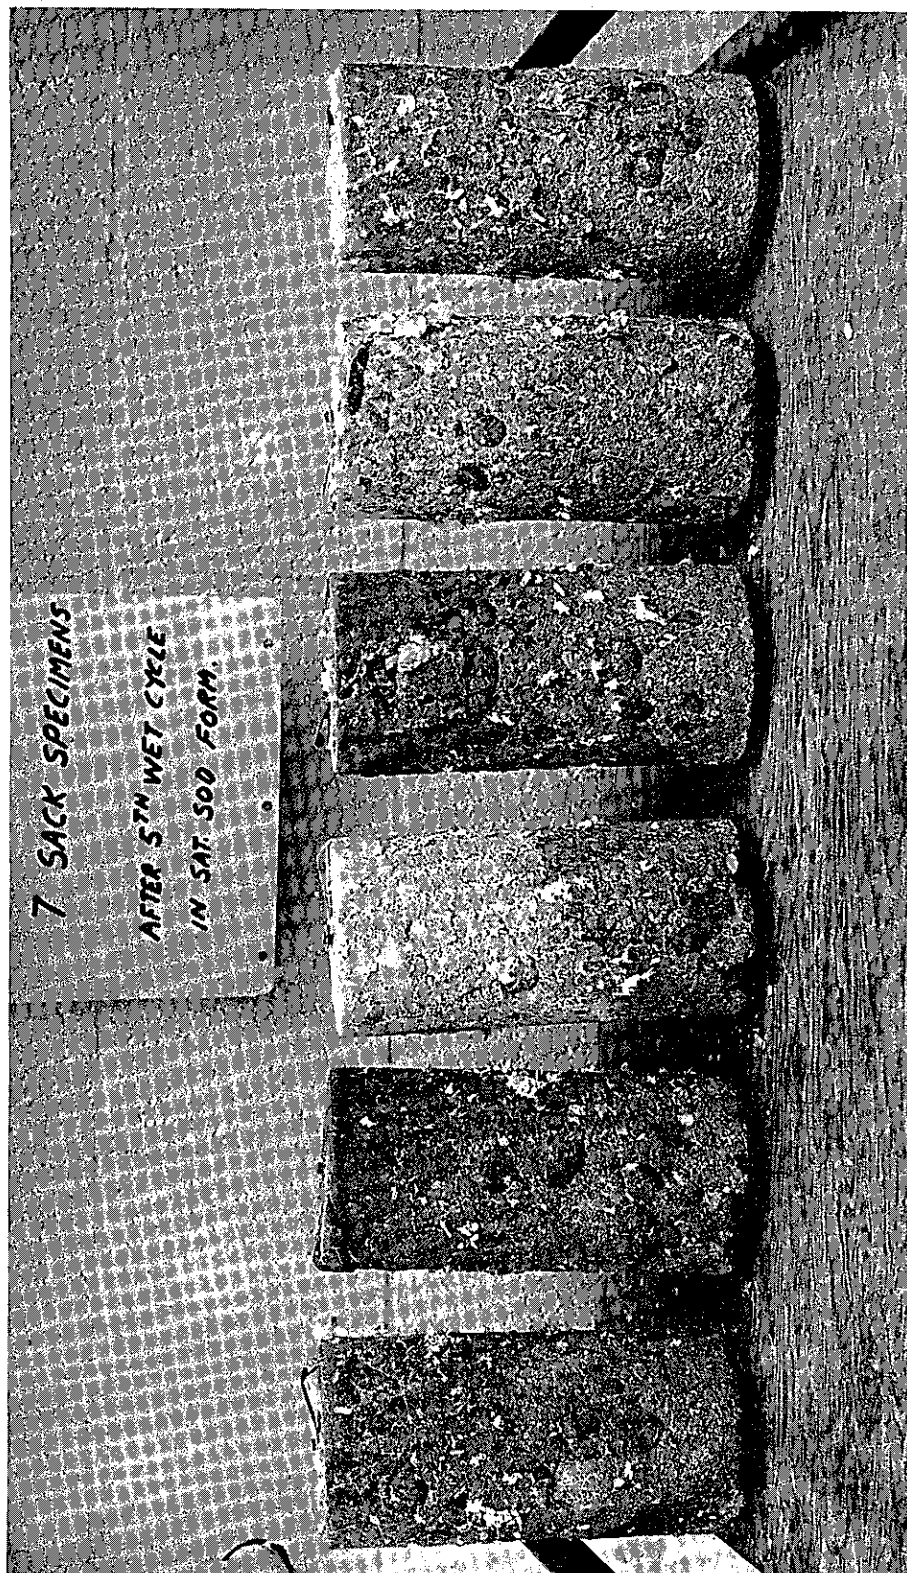
Figure 11. Amount of concrete deterioration after five and six cycles of alternate immersion in sodium formate for 7-sack concrete

- (a) Both 4-1/2 and 7-sack concrete cylinders are not significantly affected after 7 cycles of wet-dry tests in tap water.
- (b) Sodium formate caused severe deterioration of both 4-1/2 and 7-sack concrete specimens. Visible surface scaling was evident after only two cycles. Figure 7 shows the condition of 4-1/2-sack concrete specimens after removing them from solutions at the completion of the wet portion of the fourth cycle. Crystal growth and severe disintegration is obvious. Only one more cycle was possible before terminating tests employing sodium formate because of the extreme disintegration of the concrete.
